# Using STED and ELSM confocal microscopy for a better knowledge of fused silica polished glass interface

**Abstract:** Characteristics and nature of close surface defects existing in fused silica polished optical surfaces were explored. Samples were deliberately scratched using a modified polishing process in presence of different fluorescent dyes. Various techniques including Epi-fluorescence Laser Scanning Mode (ELSM) or STimulated Emission Depletion (STED) confocal microscopy were used to measure and quantify scratches that are sometimes embedded under the polished layer. We show using a non-destructive technique that depth of the modified region extends far below the surface. Moreover cracks of 120 nm width can be present ten micrometers below the surface.

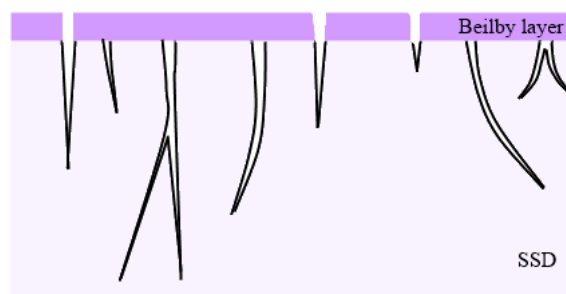
Fig. 1. Schematic structure of the fused silica interface after polishing.

Both SSD and process induce contamination can lead to laser damage at 351 nm. High concentration of ceria in the polished layer induces gray haze *e.g.* during damage testing [4, 5]. Damage density can thus be linked to pollutant concentration for high degrees of pollution [6]. As depicted in Fig. 1, residual SSD can also lead to laser damage [7, 8].

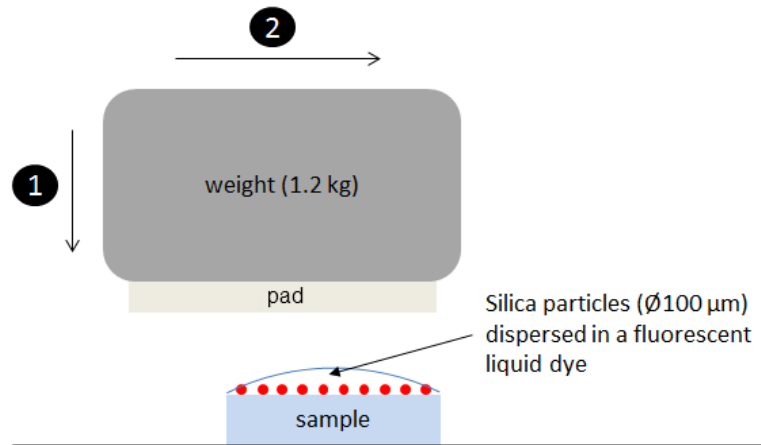
Fig. 2. Schematic representation of the experimental method used for the production of polishing-like scratches on sample surfaces.

Studying defects in polished fused silica glass interface is very difficult. In contrast with ground surfaces, subsurface defects density is rather weak. Moreover the width of fractures is less than a micrometer which is also beyond most of classic optical apparatus resolution. Consequently, groups working on this topic are used to create subsurface defects artificially in large quantity using a process which derives from polishing and uses polishing slurry polluted with large hard particles [11]. The morphology of such artificial imperfections matches well process-related polishing scratches that appear from the last grinding/polishing operations. We retained a similar approach to create subsurface defects on our polished samples. As shown in Fig. 2, an adhesive polishing pad was stuck on a 1.2 kg weight. A slurry containing silica particles of 100  $\mu\text{m}$  diameter dispersed in a D.I. water was preliminary deposited on the sample surface. The weight is moved down to the clamped sample till contact (step 1 of Fig. 2) and is translated one time over the sample surface (step 2 in Fig. 2). Unidirectional scratches with controlled density and width are obtained on the

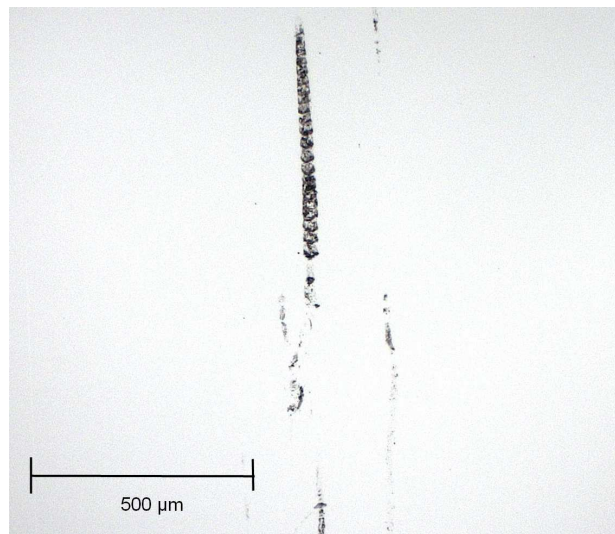
Fig. 3. Typical scratch created by the scratching process.

Typical scratches created by this process are shown on Fig. 3. Image was obtained using a bright field microscope in dark interference contrast mode and a 20x objective. Conchoidal shape, trailing indent fractures are created with morphology similar to polishing process induced scratches [13].

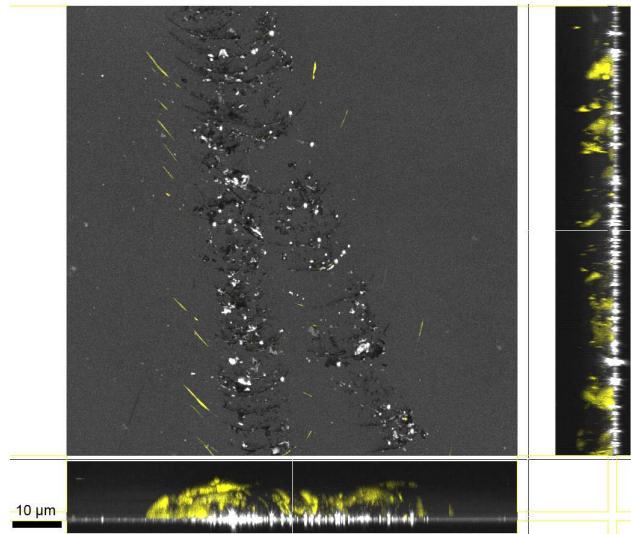
Fig. 5. Scratch observed in reflection (black and white scale) and ELSM mode with Lucifer Yellow tagging (yellow scale). Top view (central), side view from left (right) and side view from top (bottom) – All stacks represented.

A first set of samples was scratched using the procedure detailed in section 2.1 using silica particles, D.I. water and Lucifer Yellow fluorescent dye for subsurface defects tagging. A typical image obtained in both ELSM mode and reflection mode is shown in Fig. 5. Central image is a top view and includes the entire stack of images. The right side image is a view looking from the left and includes the entire stack. The bottom side image is a side view looking from the top and including all the stacks. Reflection mode signal is represented in black and white, ELSM mode in Yellow. Analysis of top and sides views brings information on surface and subsurface defects. Two main surface scratches created by silica particles are visible. It can also be seen that Lucifer yellow tagging is efficient, allowing imaging of subsurface structures not observed in reflection mode.

In the example of Fig. 5, the subsurface defect observed in ELSM mode is associated with a surface scratch. We presume that both scratch and subsurface cracks are created by the action of silica particles acting as indents sticking and slipping on the surface. But such a behavior is not always observed as shown in Fig. 6. In this later less frequent case, no surface defect is observed in reflection mode whereas ELSM signal is present, meaning the existence of subsurface defects. Subsurface defects are here embedded under the polished layer.

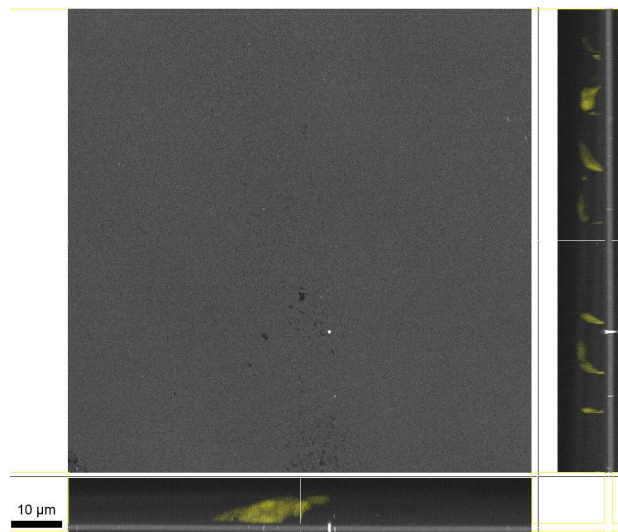
Fig. 6. Subsurface defect observed in reflection (black and white scale) and ELSM mode with Lucifer Yellow tagging (yellow scale). Top view (central), side view from left (right) and side view from top (bottom) – All stacks represented.

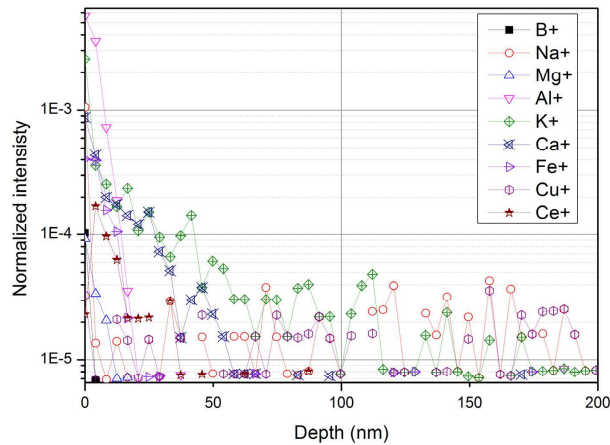
Fig. 7. ToF-SIMS profile obtained on a polished sample. A 50 to 75 nm polished layer is observed.

evaluate uniformity with no significant differences observed between profiles. An example of a ToF SIMS profile is given in Fig. 7.

Process induced contamination of the fused silica glass close surface can be seen with traces of cerium, aluminum and iron (tooling, polishing slurries) but also calcium and potassium (water). Thickness of this contaminated layer is 50 to 75 nm.

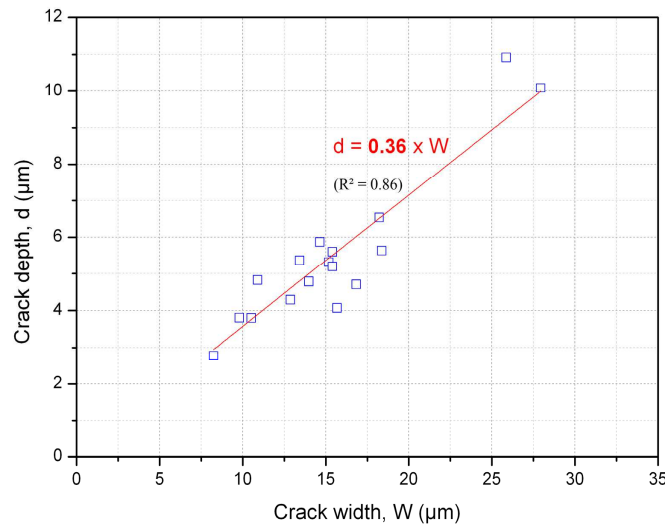
Fig. 8. Correlation between *mean* crack depth ( $d$ ) and crack width ( $W$ ). Best linear fit is shown in red.

Firstly, we measured the crack width and depth of numerous scratches. Width is defined as the length across the crack on the surface as defined by Suratwala [19]; it was obtained from the reflection mode confocal image. Depth of each crack was measured by analyzing the ELSM mode image stacks. We were then able to represent in Fig. 8 the relation between crack depth ( $d$ ) and crack width ( $W$ ).

Data linear fitting shows that *mean* crack depth is linked to width by a  $d = 0.36 \times W$  relation. This result is in good agreement with the  $d = 0.35 \times W$  relation established by Surawala using a destructive method combining MRF wedge polishing to an automatic raster microscope imaging [19]. Consequently dye is likely to penetrate along the full subsurface fracture.

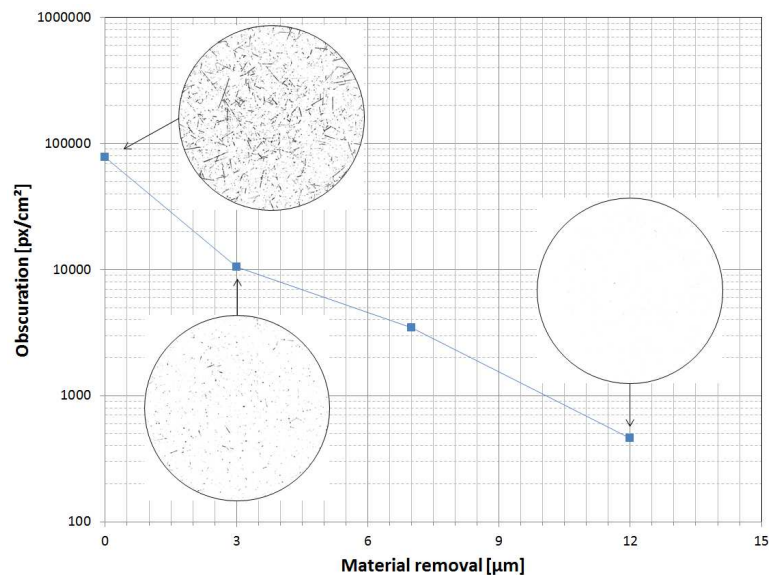
Fig. 9. Evolution of the crack obscuration during iterative material removal. The inserts correspond to DMS images of the initial state and after 3  $\mu\text{m}$  and 12  $\mu\text{m}$  material removal. Light HF wet etch was performed before DMS.

Secondly, a magneto-rheological fluid (MRF) finishing machine was used to suppress created defects from the scratched samples. MRF is a deterministic polishing method that permits local material removal by shear forces created by a fluid in contact with workpiece. It therefore induces very low to almost no SSD during polishing [20, 21]. MRF polishing was realized on a QED Q-22 XE machine using a standard fluid containing cerium oxide particles and a 50 mm diameter wheel. The following parameters were used: wheel speed of 600 rpm, pump speed of 80 rpm, spot depth of about 150 nm. A set of samples was scratched on a LOGITECH PM5 polishing machine using a cerium slurry polluted with 0.1 g/l of 9  $\mu\text{m}$  alumina particles. We verified by confocal microscopy that using this other scratching process the  $d = 0.36 \times W$  was fulfilled, meaning that similar subsurface defects were created. Iterative MRF uniform layer removals and DMS imaging (see section 2.2) were performed to track subsurface defect removal. Figure 9 shows the evolution of surface obscuration (step 5 of Fig. 4) after iterative material removals on a scratched sample with a mean crack width of 10  $\mu\text{m}$ .

After 3  $\mu\text{m}$  material removal, which approximately corresponds to the mean crack depth of scratches estimated thanks to the  $d = 0.36 W$  relation, ImageJ post treatment shows a crack obscuration reduced by a decade. Almost no defects are seen on the DMS imaging thus confirming our depth estimation. DMS analysis using complete removal of any fracture is obtained with a 12  $\mu\text{m}$  material removal which is approximately the crack width. This result is in good agreement with recent results demonstrating that a 90% probability of scratch removal is obtained when removing a depth equal to its width [13].

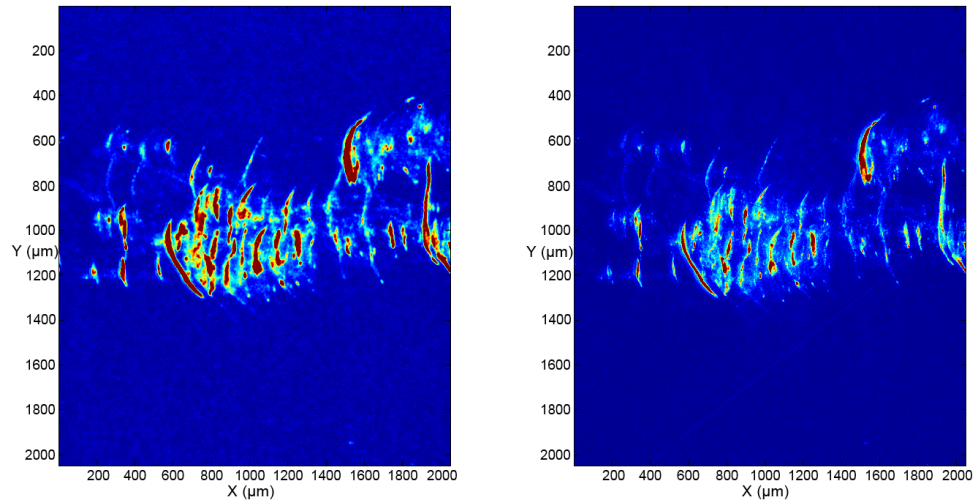
Fig. 10. ELSM (left) and STED (right) mode confocal imaging of subsurface fractures, 3  $\mu\text{m}$  below the surface.

ATTO647N fluorescent dye for subsurface defects tagging. The interest of STED is to improve the resolution of the measurement and consequently gather finer details in the stack. This improvement can be seen in Fig. 10 which compares subsurface fractures evaluated 3  $\mu\text{m}$  below a surface scratch.

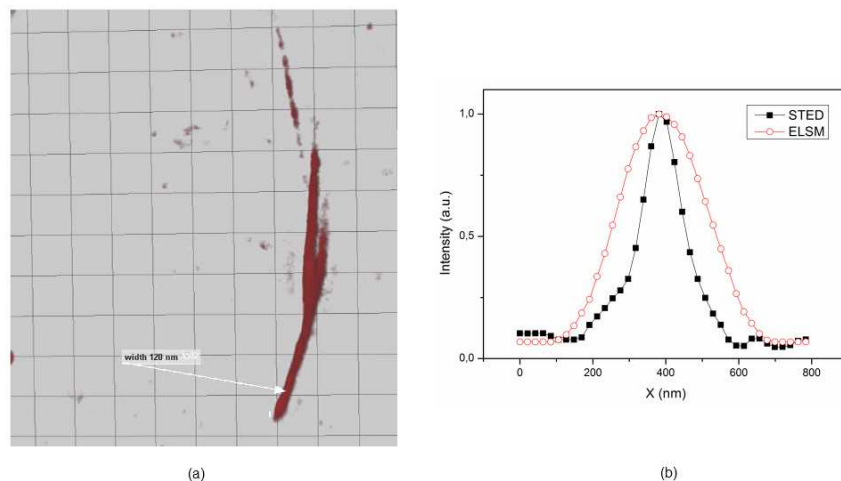
Fig. 11. Measurement of a subsurface fracture width on an isolated fracture ([Media 1](#)) at about 2.5  $\mu\text{m}$  below the surface (a) – X-profile of crack width estimated in ELSM (red circles) and in STED mode (black rectangles) at the pointed location (arrow in (a)) (b).

We also used STED stacks of different subsurface fractures to estimate crack width below the surface. An example is given on a single fracture extending about 2.5  $\mu\text{m}$  below the surface and presented in Fig. 11 and in [Media 1](#). A width of 120 nm FWHM (Full Width at Half Maximum) is measured 2.5  $\mu\text{m}$  below the surface in STED mode whereas it is given at 280 nm FWHM in ELSM mode (Fig. 11(b)). Similar sizes can be measured on Fig. 10 on fine details of subsurface fractures and equivalent width are found down to ten micrometers below the surface. This order of magnitude is in good agreement with width of subsurface cracks supposed to play a role in damage initiation at the wavelength of 351 nm [7, 22–24]. For example, Genin *et al.* demonstrated that 100 nm width and few micrometers depth cracks can induce light intensity enhancements of 10x to 100x depending on their orientation [7].
